CURTAINS WITHOUT BORDERS

SURVEY AND TREATMENT PROPOSAL

Site: Former Grange Hall, New Hampton, NH

Description of Curtain: Grand Drape Advertising Curtain

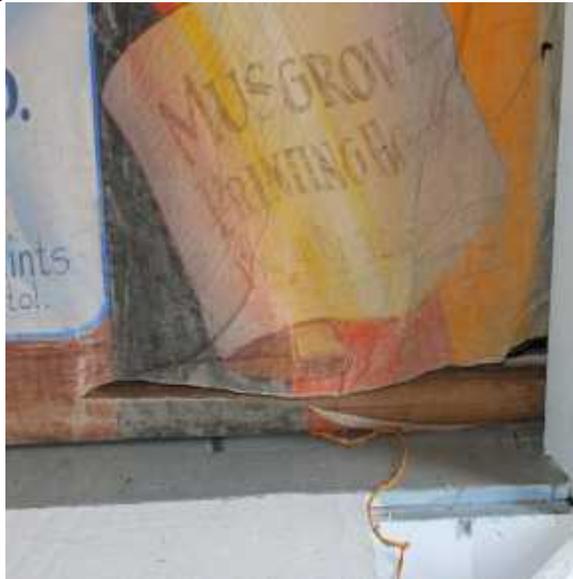
Overall Condition of Fabric: several large tears, one about 3 ft long at bottom right edge.

Bottom Edge: 6-inch unpainted tacking margin with numerous small rips and tears. Large tear at lower right corner.

Repair rips and tears throughout, with appropriate support materials. There are numerous small rips and holes and one long rip, approximately 30”.

Stabilize raw edges at top, bottom and side edges as needed, to prevent vertical or horizontal rips.

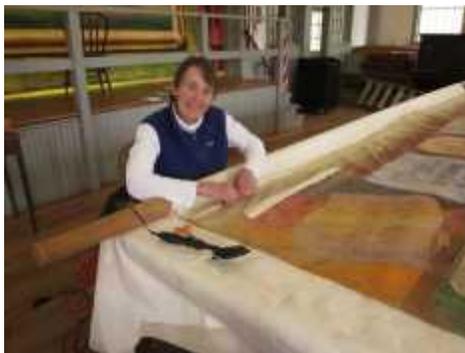
1. The curtain was removed from its temporary storage wrapping and placed on the prepared work surface. The curtain was gently unrolled and scrolled out carefully as not to disturb the fragile paint layer. During the unrolling process, the verso of the curtain was gently vacuumed using a HEPA vacuum set on low suction. This reduced the loose dirt on the verso. The front of the curtain was not brushed or touched due to the friable nature of the media.
2. During step 1, small and large tears were mended on the verso using 100% cotton muslin patches adhered with BEVA 371 (Bi-ethylene vinyl acetate TALAS) film using a tacking iron set to 140 F.

3. The raw edge at the top was stabilized using 2" wide muslin strip adhered with BEVA in a similar manner as in step 2. The bottom edge had 2 ½" of BEVA film applied with a 20" wide new muslin tail attached to help with attachment to the old, original roller. The left and right margins were both quite ragged and they were turned under at the design margin and secured with BEVA on the verso.

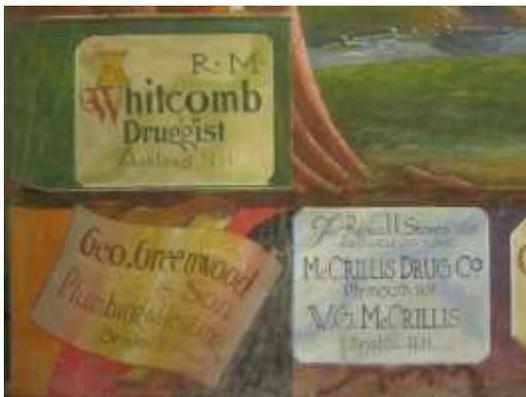
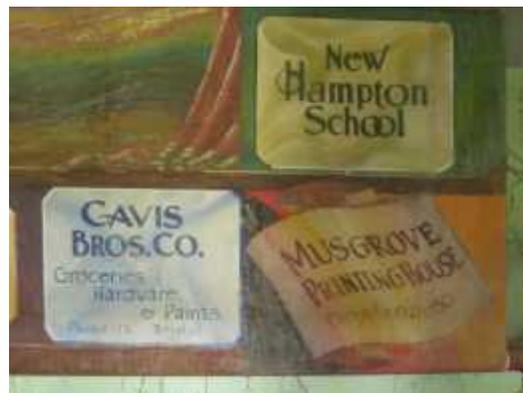
8. The disfiguring water stains and areas of paint loss were inpainted using acrylic paints (Flasche matte acrylic paints) applied locally with a small brush. The top central water stain will be inpainted by Wylie Garcia in the near future.
