CURTAINS WITHOUT BORDERS

SURVEY AND TREATMENT PROPOSAL

Site: Former Grange Hall, New Hampton, NH

Description of Curtain: Grand Drape Advertising Curtain

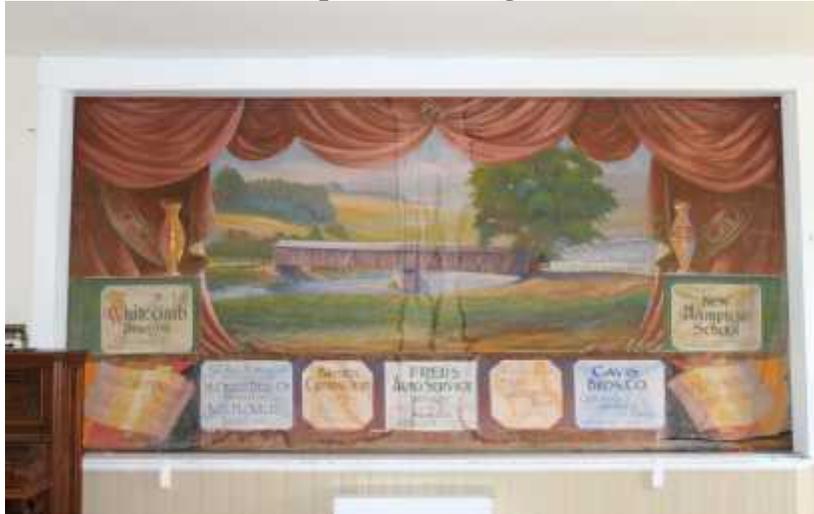
Overall Condition of Curtain: fragile, due to tears and powdery paint due to water damage.

Overall Condition of Fabric: several large tears, one about 3 ft long at bottom right edge.

Stains: yes, central water stains the height of the curtain

Water Damage: yes, primarily in central area

Repair rips and tears throughout, with appropriate support materials. There are numerous small rips and holes and one long rip, approximately 30”.

Selectively tone mended areas and disfiguring stains using appropriate paints. This will take a full day.

8. The disfiguring water stains and areas of paint loss were inpainted using acrylic paints (Flasche matte acrylic paints) applied locally with a small brush. The top central water stain will be inpainted by Wylie Garcia in the near future.

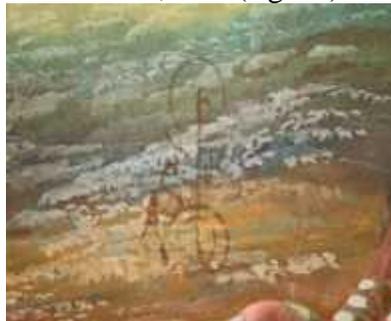
Artist: Arthur. S. Ives, North Woodstock, NH (signed)
